Test Report No. 7191132843-MEC16-SL
dated 08 APR 2016

Load test on cable grille and cable railing

The following five sets of test frame with the respective cable configurations were received on 29th Feb 2016 and 06th Apr 2016:

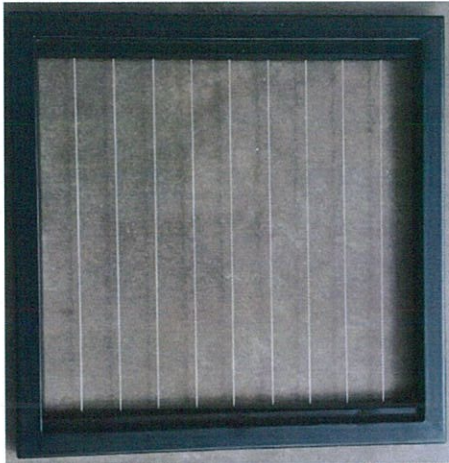
Photo. 1 : 850 x 850 (Premium Aplus)

- 1) Three sets of 850mm x 850mm test frame with vertical tension cables spacing out at 75mm apart (Refer photo 1 & 2);
- 2) Three sets of 850mm x 850mm test frame with vertical tension cables spacing out at 75mm apart and a restrainer cable running across the vertical cables at 425mm (Refer to Photo3 & 4);
- 3) Two set of 500mm x 500mm test frame with vertical tension cables spacing out at 75mm apart (Refer to Photo 5 & 6);
- 4) Two set of 500mm x 500mm test frame with vertical tension cables spacing out at 75mm apart and a restrainer cable running across the vertical cables at 205mm (Refer to Photo 7 & 8).

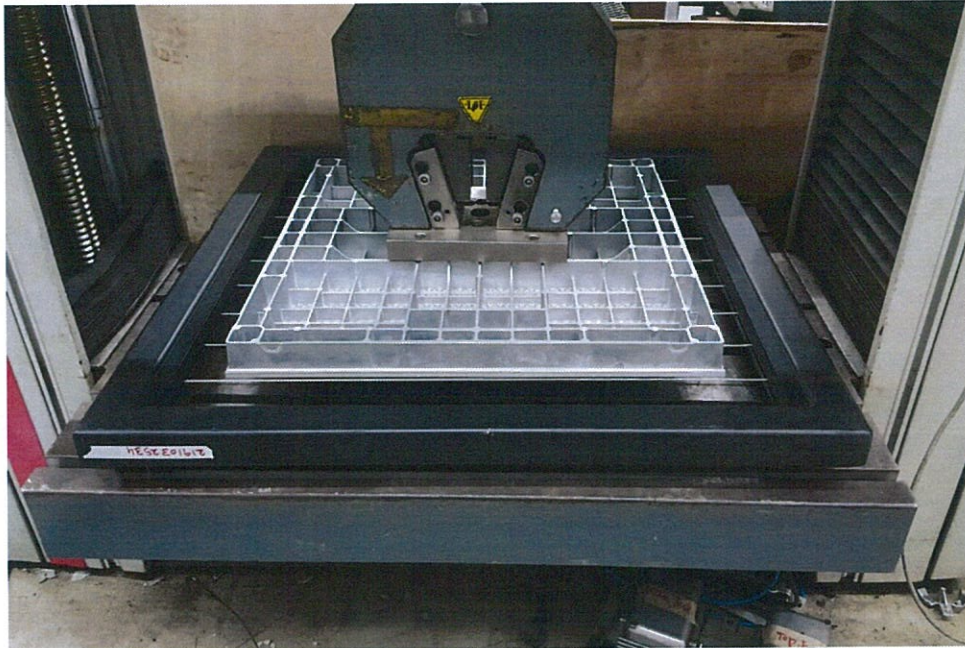
- 1) The 850mm x 850mm test frame with vertical tension cables spacing out at 75mm apart was placed onto the test bed of the Universal Testing Machine (UTM). An indenter plate with a dimension of 600mm x 600mm was then placed at the centre of the test frame (Refer to Photo 9). Compressive load was applied to the indenter till failure occurs and the maximum load was recorded.

Photo. 9 : Typical test setup for Compression Test Method 1

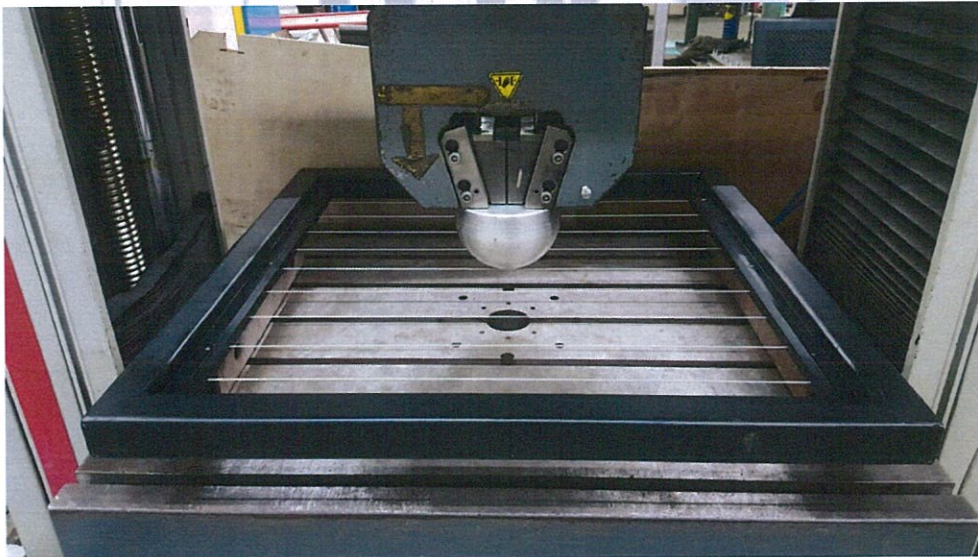
- 2) The 850mm x 850mm test frame with vertical tension cables spacing out at 75mm apart was placed onto the test bed of the UTM. A sphere indenter with a diameter of 150mm was then placed at the centre of the test frame (Refer to Photo 10). Compressive load was applied to the indenter till failure occurs and the maximum load was recorded.
- 3) The 850mm x 850mm test frame with vertical tension cables spacing out at 75mm apart and a restrainer cable running across the vertical cables at 425mm was placed onto the test bed of the UTM. A sphere indenter with a diameter of 150mm was then placed at the centre of the test frame (at the inter-crossing of the cable – Refer to Photo 11). Compressive load was applied to the indenter till failure occurs and the maximum load was recorded.

Photo. 10 : Typical test setup for Compression Test Method 2

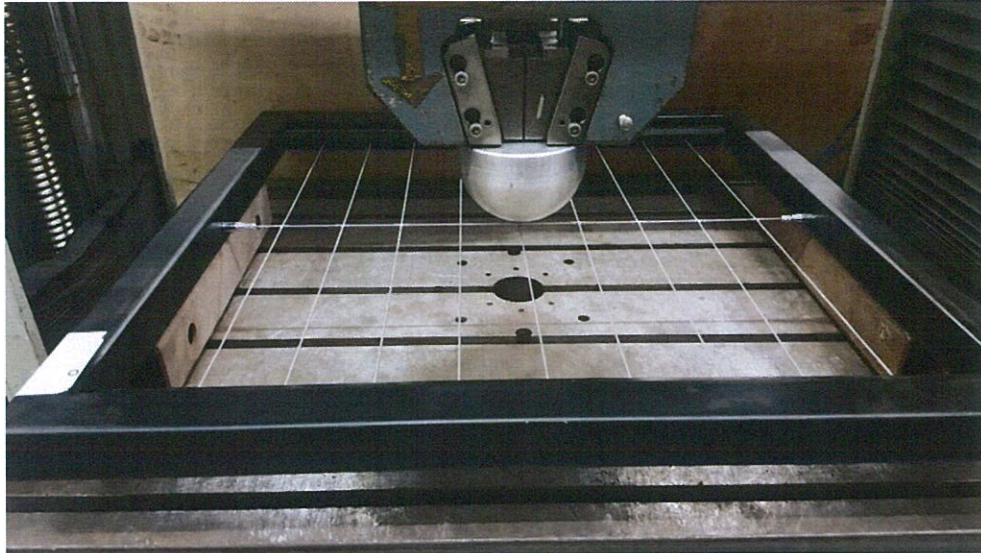
Photo. 11 : Typical test setup for Compression Test Method 3

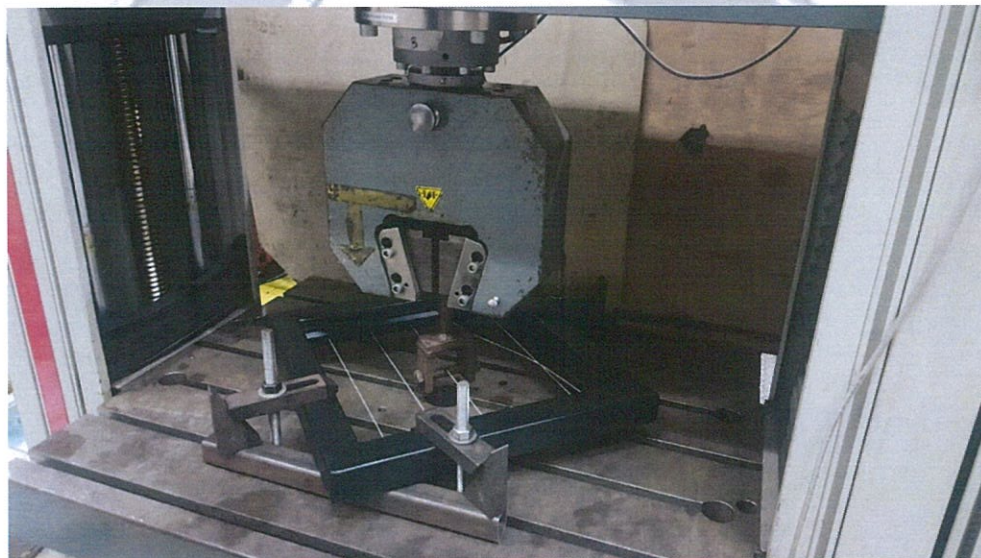
- 1) The 500mm x 500mm test frame with vertical tension cables spacing out at 75mm apart was secured onto the test bed of the UTM. One length of the cable was cut prior to the test. A tension load was applied on the cable (at the centre of the cable – Refer to Photo 12) next to the cut cable till failure occurs and the maximum load was recorded
- 2) The 500mm x 500mm test frame with vertical tension cables spacing out at 75mm apart with a restrainer cable running across the vertical cables at 250mm was secured onto the test bed of the UTM. One length of the cable was cut prior to the test. A tension load was applied on the cable (at the inter-crossing of the cable – Refer to Photo 13) next to the cut cable till failure occurs and the maximum load was recorded.

Photo. 12 : Typical test setup for Tension Test Method 1

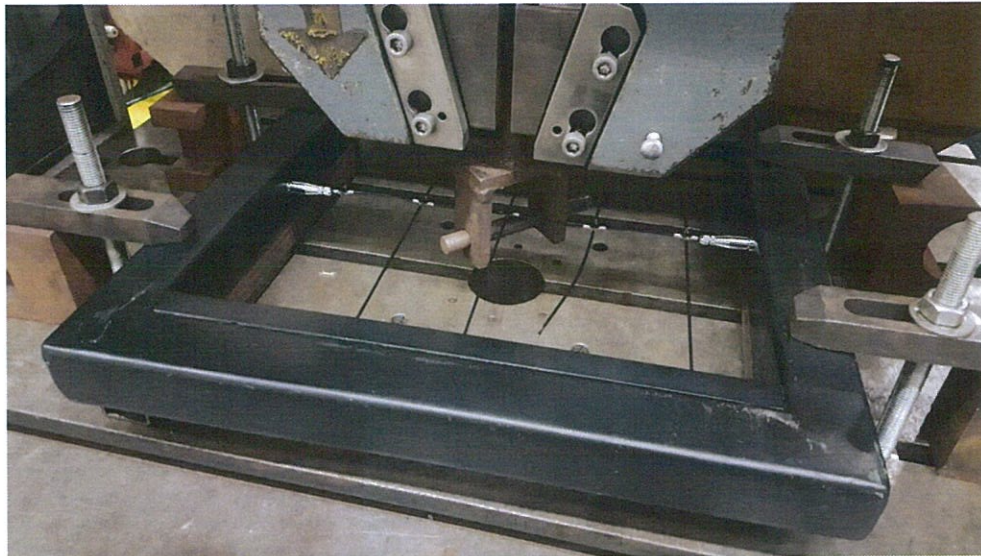
Photo. 13 : Typical test setup for Tension Test Method 2

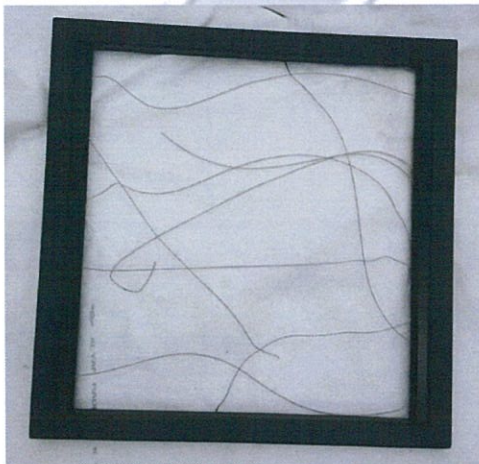
Sample Reference	Max Load (N)	Observation
Premium Aplus - 850mm x 850mm test frame with vertical tension cables.	9988	Cables broke (Refer to Photo 14)
Supreme Black - 850mm x 850mm test frame with vertical tension cables.	8800	Cable broke (Refer to Photo 15)

Photo. 14 : Wire broke

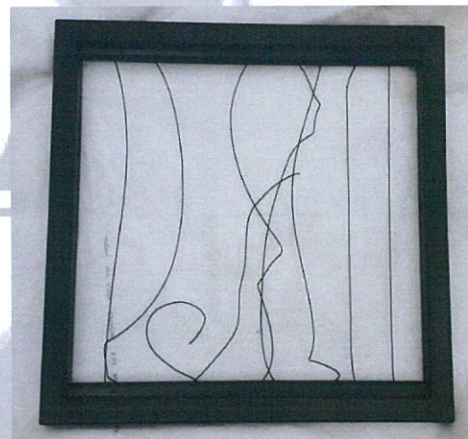
Photo. 15 : Wire broke

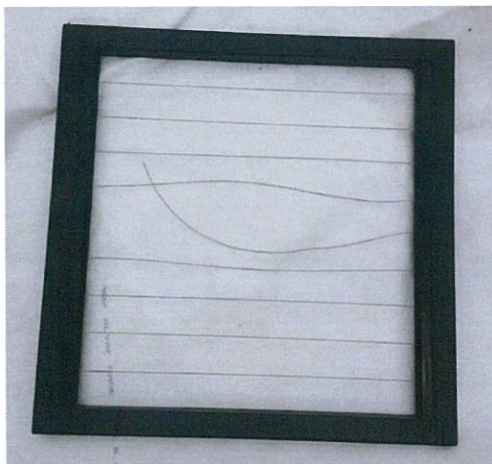
Sample Reference	Max Load (N)	Observation
Premium Aplus - 850mm x 850mm test frame with vertical tension cables.	986	Cable broke (Refer to Photo 16)
Supreme Black - 850mm x 850mm test frame with vertical tension cables.	1073	Cable broke (Refer to Photo 17)
Premium Aplus - 850mm x 850mm test frame with vertical tension cables and a restrainer cable.	1354	Cable broke (Refer to Photo 18)
Supreme Black - 850mm x 850mm test frame with vertical tension cables and a restrainer cable.	1767	Cable broke (Refer to Photo 19)

Photo. 16 : Wire broke

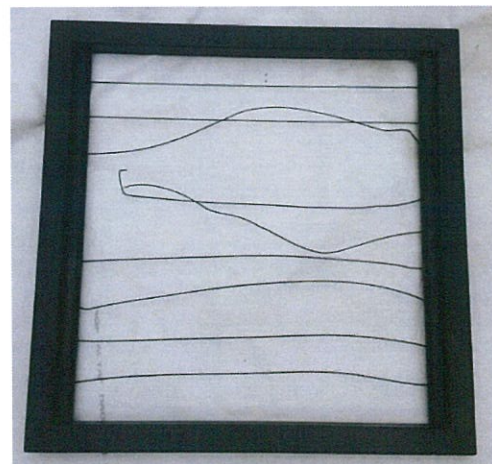
Photo. 17 : Wire broke

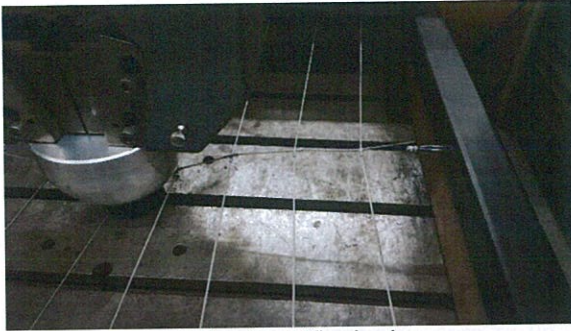
Photo. 18 : Wire broke

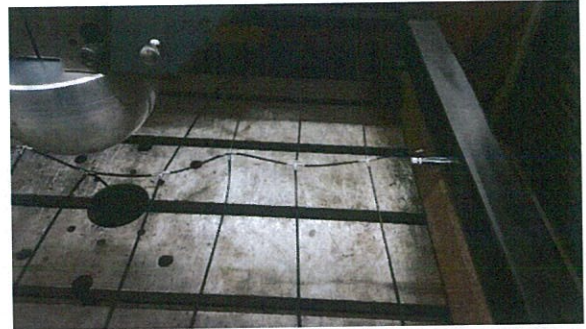
Photo. 18 : Wire broke

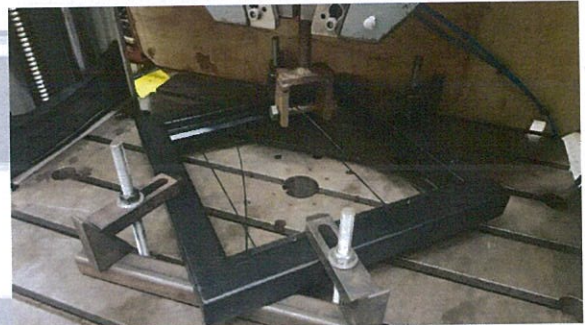
Sample Reference	Max Load (N)	Observation
Premium Aplus - 500mm x 500mm test frame with vertical tension cables.	726	Cable pulled-off (Refer to photo 20)
Supreme Black - 500mm x 500mm test frame with vertical tension cables.	94	Cable broke (Refer to Photo 21)
Premium Aplus - 500mm x 500mm test frame with vertical tension cables and a restrainer cable	764	Cable broke (Refer to Photo 22)
Supreme Black - 500mm x 500mm test frame with vertical tension cables and a restrainer cable	772	Cable broke (Refer to Photo 23)

Photo. 21 : Wire broke

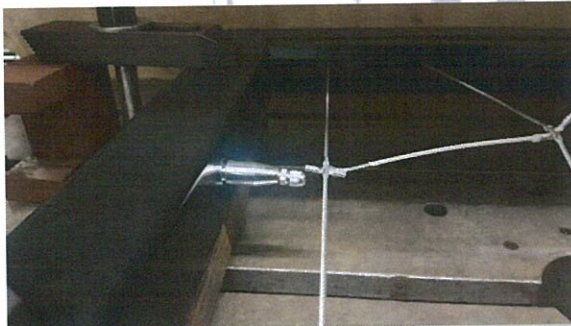
Photo. 22 : Wire broke

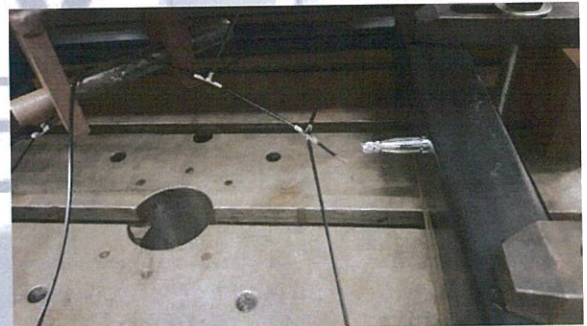
Photo. 23 : Wire broke
